Eyri, Arnarlax hf.
B-bottom survey,
March 2019
(maximum biomass survey)

Information client			
Titel	Eyri, Arnarlax hf. B-bottom survey, March 2020		
Report number	APN-61958.B01		
Site name	Eyri	Coordinates site	65°34.850 N 023°58.440 V
County	Vestur Barðastrandasýsla	Municipality	Vesturbyggð
MTB-or estimated max biomass	5000 tonn	Site manager/contact	Silja Baldvinsdóttir
Client name	Arnarlax hf.

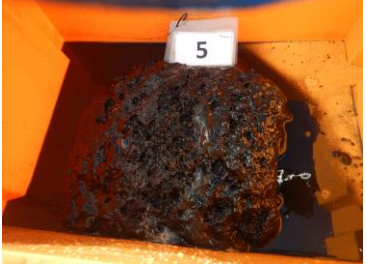
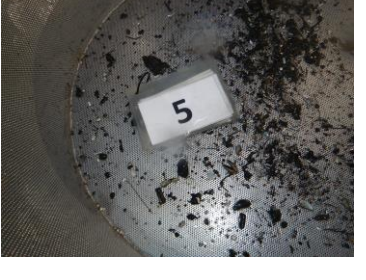
<p><i>St 5</i></p>

This indicates small organic load at the Eyri site during the current production cycle. The only sampling station with condition 3 «bad» (St. 5) is placed on the eastern side of the array of cages in the concurrent with the dominant dispersing current. Dominating current (15 m) is in direction north-northwest (330 - 345 degrees) with slight counter current from south-east (150 degrees). Average current speed is measured to be 5,2 cm/s.
