Eyri, Arnarlax  
B-bottom survey,  
April 2021  
(fallow period)

Akvaplan-niva AS: APN 63202.B01

Information client			
Title	Eyri, Arnarlax. B-bottom survey (fallow period), April 2021		
Report number	APN-63202.B01		
Site name	Eyri	Coordinates site	65°34,723N 023°58,675V
County	Vestur - Barðastrandarsýsla	Municipality	Vesturbyggð
MTB-or estimated max biomass	7.448 tonnes	Site manager/contact	Silja Baldvinsdóttir
Client name	Arnarlax

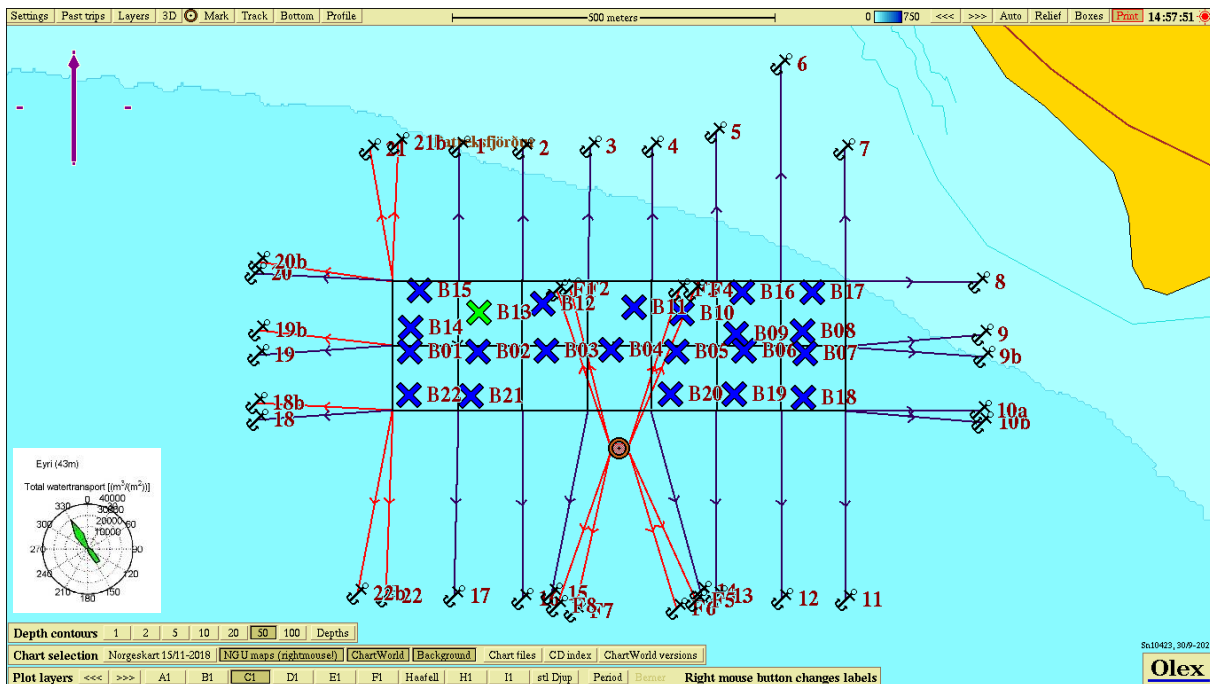
Figure 2. Chart showing Eyri farm. Sampling stations st. 1 – 22 are marked with color codes that describe the group II and III condition according to NS 9410:2016, chapter 7.11. Color codes: Blue = very good condition, green = good condition, yellow = bad condition, red = very bad condition.
