Eyrarhlíð I, Arctic Sea Farm  
B survey,  
November 2022  
(max biomass)

Information client			
Title	Eyrarhlíð I, Arctic Sea Farm. B survey (max biomass, November 2022)		
Report number	APN-64476.B01		
Site name	Eyrarhlíð I	Coordinates site	65°54,898N 23°40,390V
County	Ísafjarðarbær	Municipality	Ísafjarðarbær
MTB-or estimated max biomass	6.047 tonnes	Site manager/contact	Steinunn G. Einarsdóttir
Client name	Arctic Sea Farm

Results from B-survey according to NS 9410:2016 (main results)			
Parameters and indexes		Parameters and site status	
Gr. II. pH/Eh	1,24	Gr. II. pH/Eh	2
Gr. III. Sensory	1,02	Gr. III. Sensory	1
GR. II + III	1,13	GR. II+ III	2
Date fieldwork	22.11 2022	Date report	21.12 2022
Site status (NS 9410:2016):			<b>2</b>

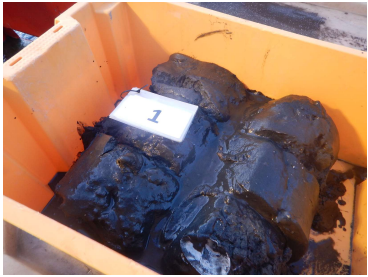
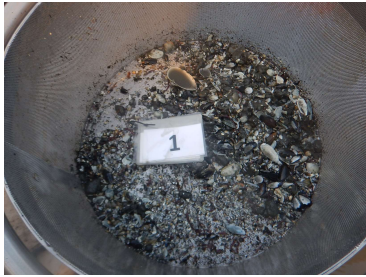
<i>St 1</i>

A yellow plastic container filled with dark, wet sediment. A white label with the number '1' is placed on top of the sediment.

A metal sieve containing the sediment from sample 1. A white label with the number '1' is placed in the center of the sieve.
<i>St 2</i>

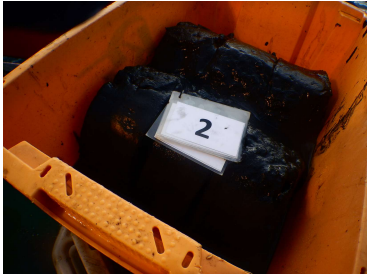
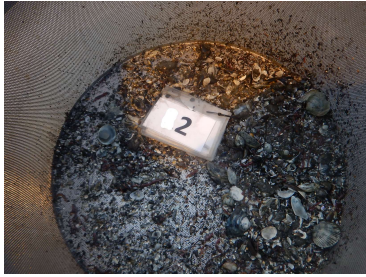
A yellow plastic container filled with dark, wet sediment. A white label with the number '2' is placed on top of the sediment.

A metal sieve containing the sediment from sample 2. A white label with the number '2' is placed in the center of the sieve.
<i>St 3</i>

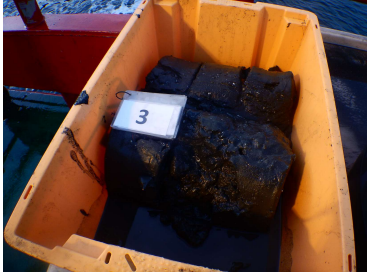
A yellow plastic container filled with dark, wet sediment. A white label with the number '3' is placed on top of the sediment.	  A metal sieve containing the sediment from sample 3. A white label with the number '3' is placed in the center of the sieve.
<i>St 4</i>

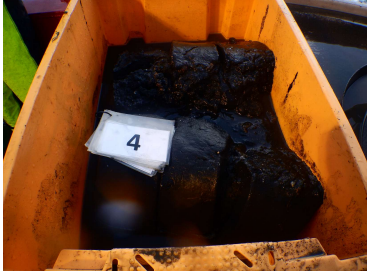
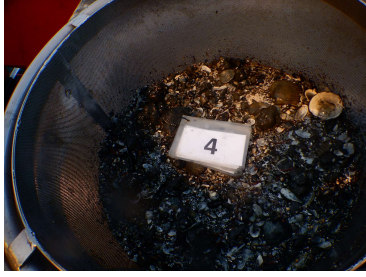
A yellow plastic container filled with dark, wet sediment. A white label with the number '4' is placed on top of the sediment.

A metal sieve containing the sediment from sample 4. A white label with the number '4' is placed in the center of the sieve.

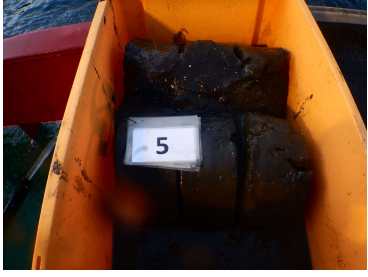
<i>St 5</i>

A yellow plastic container filled with dark, wet sediment. A white label with the number '5' is placed on top of the sediment.	  A metal sieve containing the sediment from sample 5. A white label with the number '5' is placed in the center of the sieve.
