Hvannadalur, Arctic Sea Farm
B-bottom survey,
April 2021
(maximum biomass survey)

Information client			
Title	Hvannadalur, Arctic Sea Farm. B-bottom survey, April 2021		
Report number	APN-62907.B01		
Site name	Hvannadalur	Coordinates site	65°39.222 N 024°00.891 V
County	Vesturbyggð	Municipality	Tálknafjörður
MTB-or estimated max biomass	5.104 ton	Site manager/contact	Steinunn G. Einarsdóttir
Client name	Arctic Sea Farm

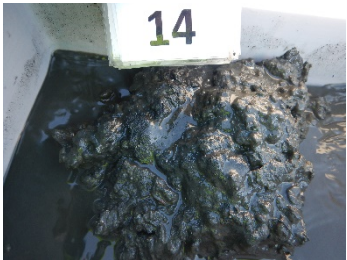
<p><i>St 12</i></p>	 	<p>NA</p>
<p><i>St 13</i></p>	<p>NA</p>	<p>NA</p>
<p><i>St 14</i></p>

There were collected valid sediment samples at fifteen out of the total sixteen sampling stations. This indicates that in general there is soft bottom in the local impact zone. The sediment type consisted mainly of clay in the whole farming area. One station was defined as hard bottom (station 13) even though it was possible to get some bottom sample for sensory analysis it was not possible to measure pH and redox. For the group II parameters (pH/Eh), eleven stations had conditions 1 «very good», one station had condition 2 «good», two stations had condition 3 «bad» and one stations had condition 4 «very bad». For sensory parameters (group III) seven stations had condition 1 «very good», eight stations had condition 2 «good» and one station had condition 3 «bad». For combined parameters II and III (pH/redox and sensory) ten stations had status 1 «very good», three stations had condition 2 «good», two stations had condition 3 «bad» and one station had condition 4 «very bad» (st. 12). Some bacteria formations most likely *Beggiatoa* was apparent at two stations (st. 12 and st. 9). Feed were visible at one station (st. 9). Animals were present in all the fifteen soft bottom samples mainly in the form of polychaetes.
