Hvannadalur, Arctic Sea Farm  
B-bottom survey,  
April 2021  
(maximum biomass survey)

Information client			
Title	Hvannadalur, Arctic Sea Farm. B-bottom survey, April 2021		
Report number	APN-62907.B01		
Site name	Hvannadalur	Coordinates site	65°39.222 N 024°00.891 V
County	Vesturbyggð	Municipality	Tálknafjörður
MTB-or estimated max biomass	5.104 ton	Site manager/contact	Steinunn G. Einarsdóttir
Client name	Arctic Sea Farm

Results from B-survey iht. NS 9410:2016 (main results)			
Parameters and indexes		Parameters and site status	
Gr. II. pH/Eh	1,00	Gr. II. pH/Eh	1
Gr. III. Sensory	1,10	Gr. III. Sensory	2
GR. II + III	1,02	GR. II+ III	1
<b>Date field work</b>	09.04 2021	<b>Date report</b>	18.06.21
<b>Site status (NS 9410:2016):</b>			<b>1</b>

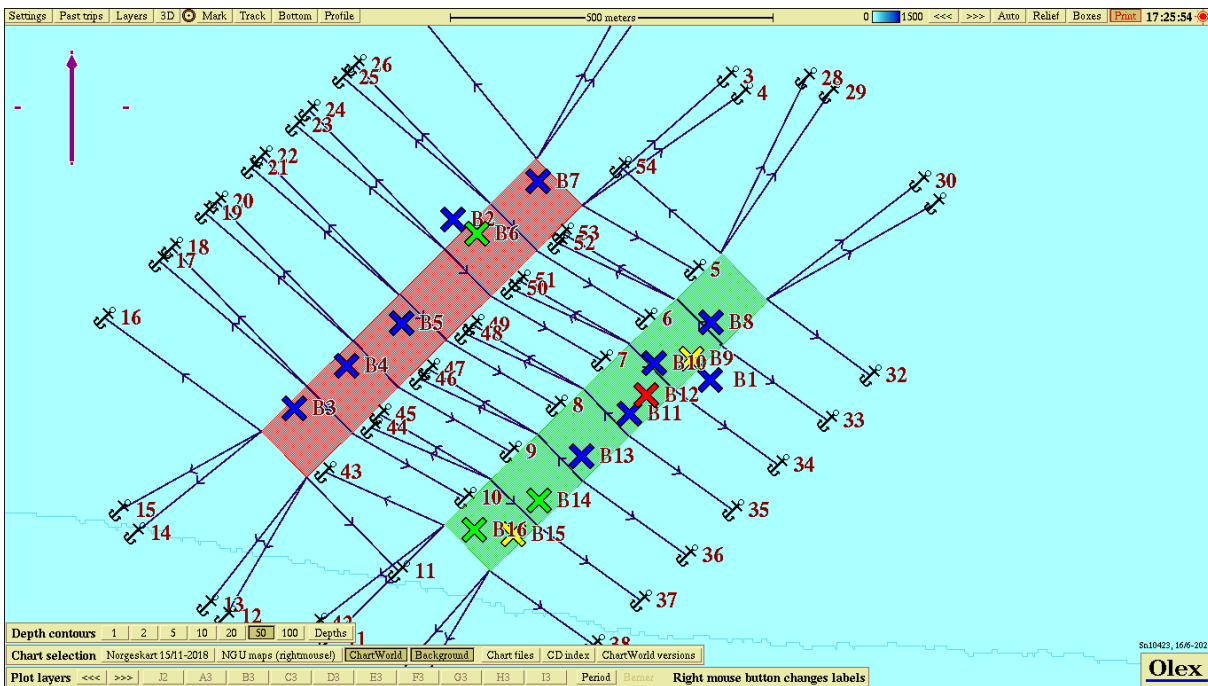
Figure 2. Chart showing depths at the site Hvannadalur. Sampling stations st. 1 – 16 are marked with color codes that describe the condition according to NS 9410:2016, chapter 7.11. Color codes: Blue = very good condition, green = good condition, yellow = bad condition, red = very bad condition.

Description of the 16 stations in the survey is given in figure 2 and table 4. Positioning of the stations was chosen based on guidance and perimeters described in NS 9410:2016 and spread around the periphery of the cages. At the Hvannadalur site the typical depth in the local impact zone is in the range from 53 – 58 m, with the shallowest parts in the south-east part (closest to land) and more depth in direction into the middle of the fjord. The placement of sampling stations was chosen to give a good picture of the condition of the whole local impact zone. It is important to evaluate the status in both the deeper and shallower parts of the local impact zone of the fish

farm. The sampling stations had a depth varying from 56 to 58 m. The placement of the sampling stations is regarded to be in accordance with the descriptions for survey of local impact zone given in NS 9410:2016.
