B-survey at Haganes, October 2024 (max biomass), Arnarlax ehf

Akvaplan-niva AS Report:
APN 66208.B01

B survey at Haganes October 2024 (max biomass), Arnarlax ehf

Author(s) Snorri Gunnarsson
Date 14.11 2024
Report No. APN 66208.B01
Number of pages 20
Distribution Through customer
Customer Arnarlax ehf
Contact person Silja Baldvinsdóttir

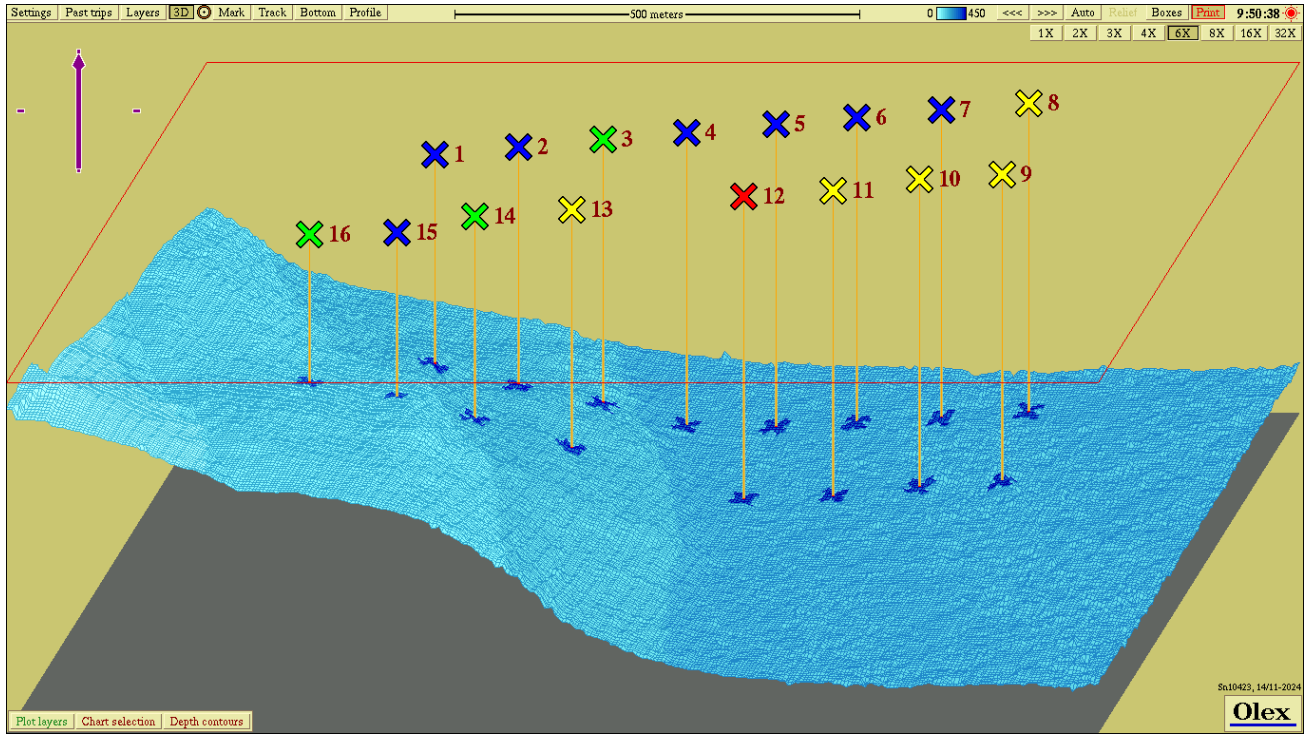
Figure 3. 3D-view of bathymetry at Haganes with stations as shown in Figure 2 and Table 4.
